Domestic Wastewater Management Plan December 2019

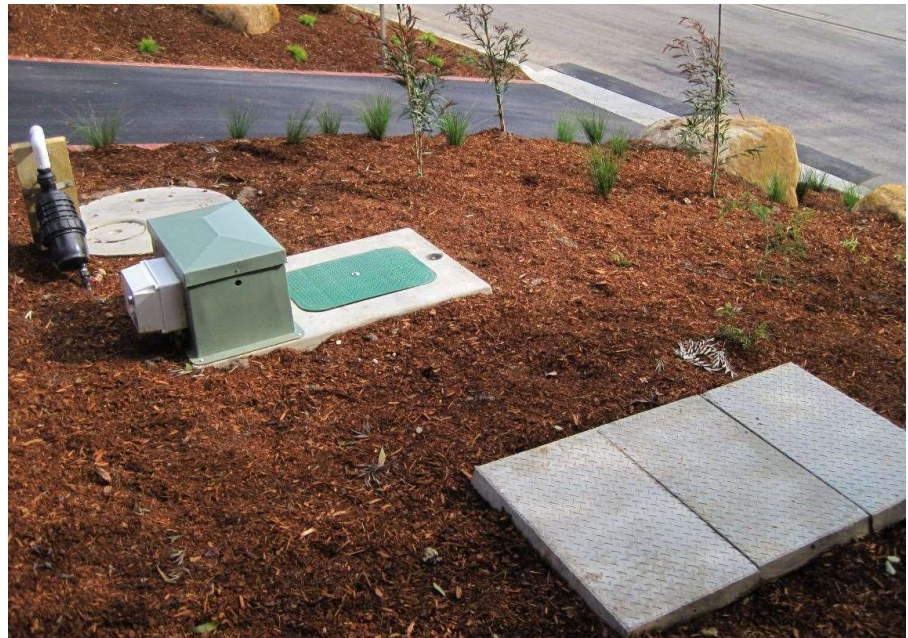
Figure 2: Treatment Plant with sub-surface irrigation

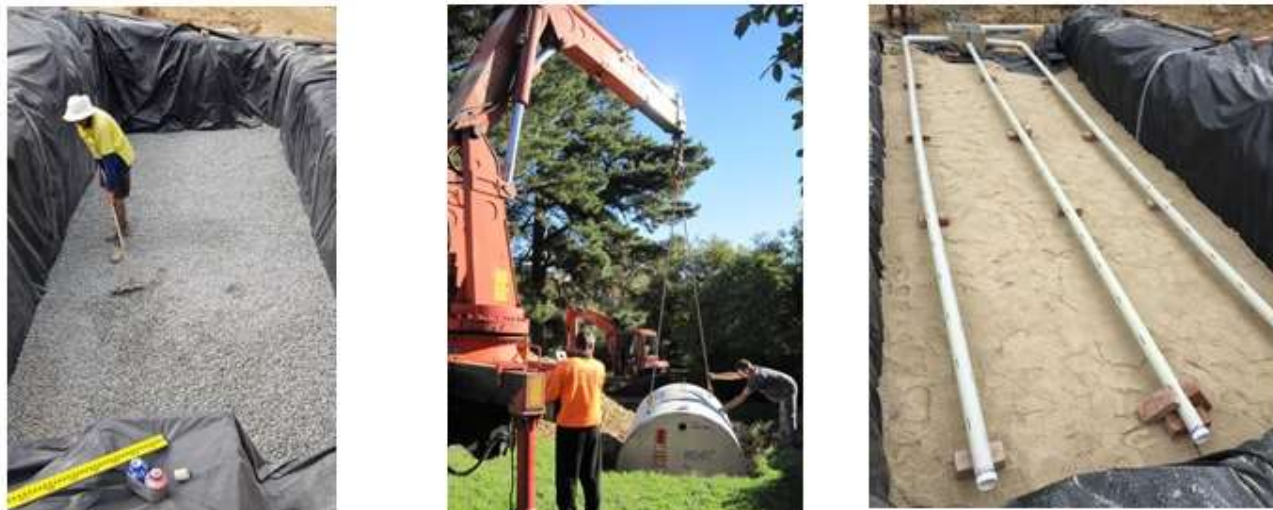
Figure 3: *Septic system components in various stage of construction/installation*

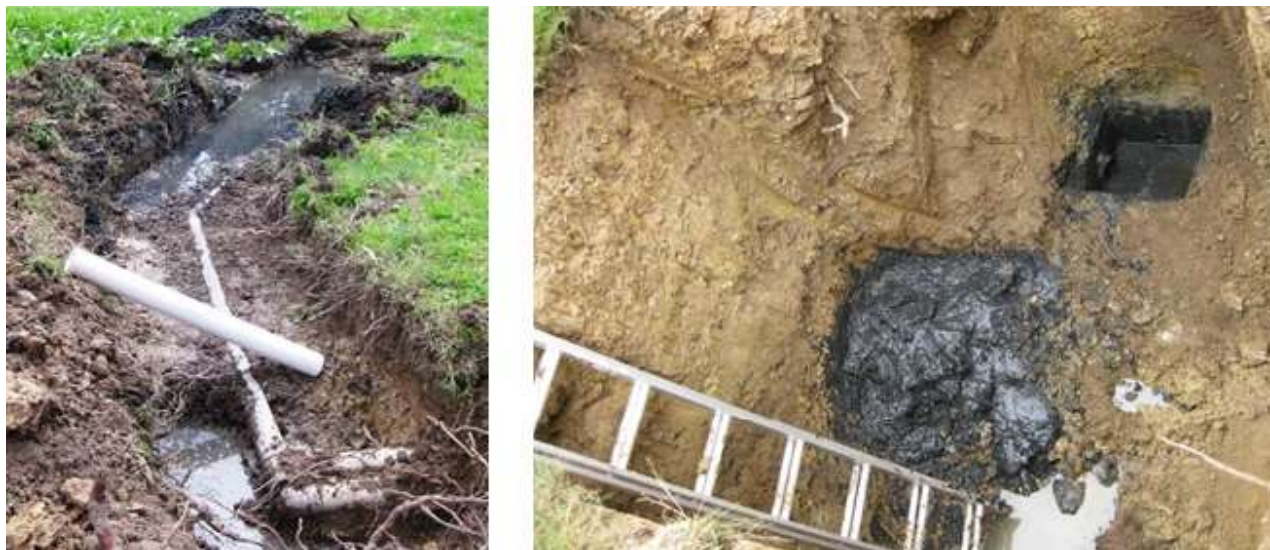
Figure 11: Flooded irrigation field and a deeply buried distribution pit (legacy system)

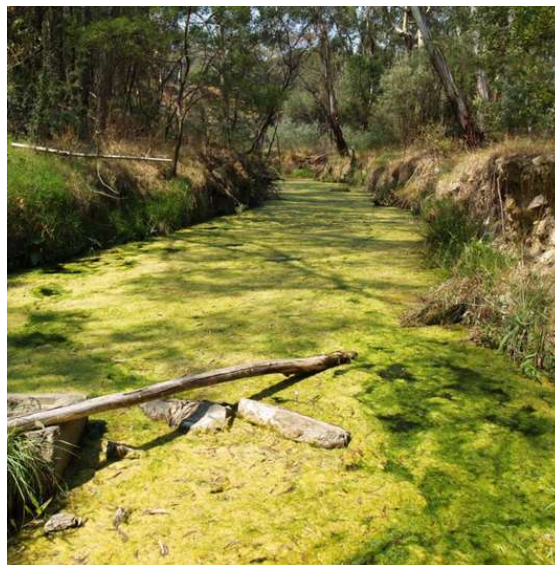
Figure 13: Algal bloom, Andersons Creek

Waterwatch monitoring in Andersons Creek indicates that the creek is being impacted by highly polluted stormwater discharging from the majority of the stormwater drains. The continuous nature of the stormwater discharge, even outside of rainfall, and the associated milky white colour, strong sewer-like odour and foamy consistency suggests that the discharge is likely to have originated as household waste water. Measurements of Ortho-phosphorus, electrical conductivity and ammonium, particularly in the upper parts of the catchment, are measured as highly degraded and can regularly exceed the limits of the Waterwatch equipment. Waterwatch data indicates that the creek is at its most polluted at the top of the catchment and improves with ground water dilution as the creek flows through the Warrandyte State Park.

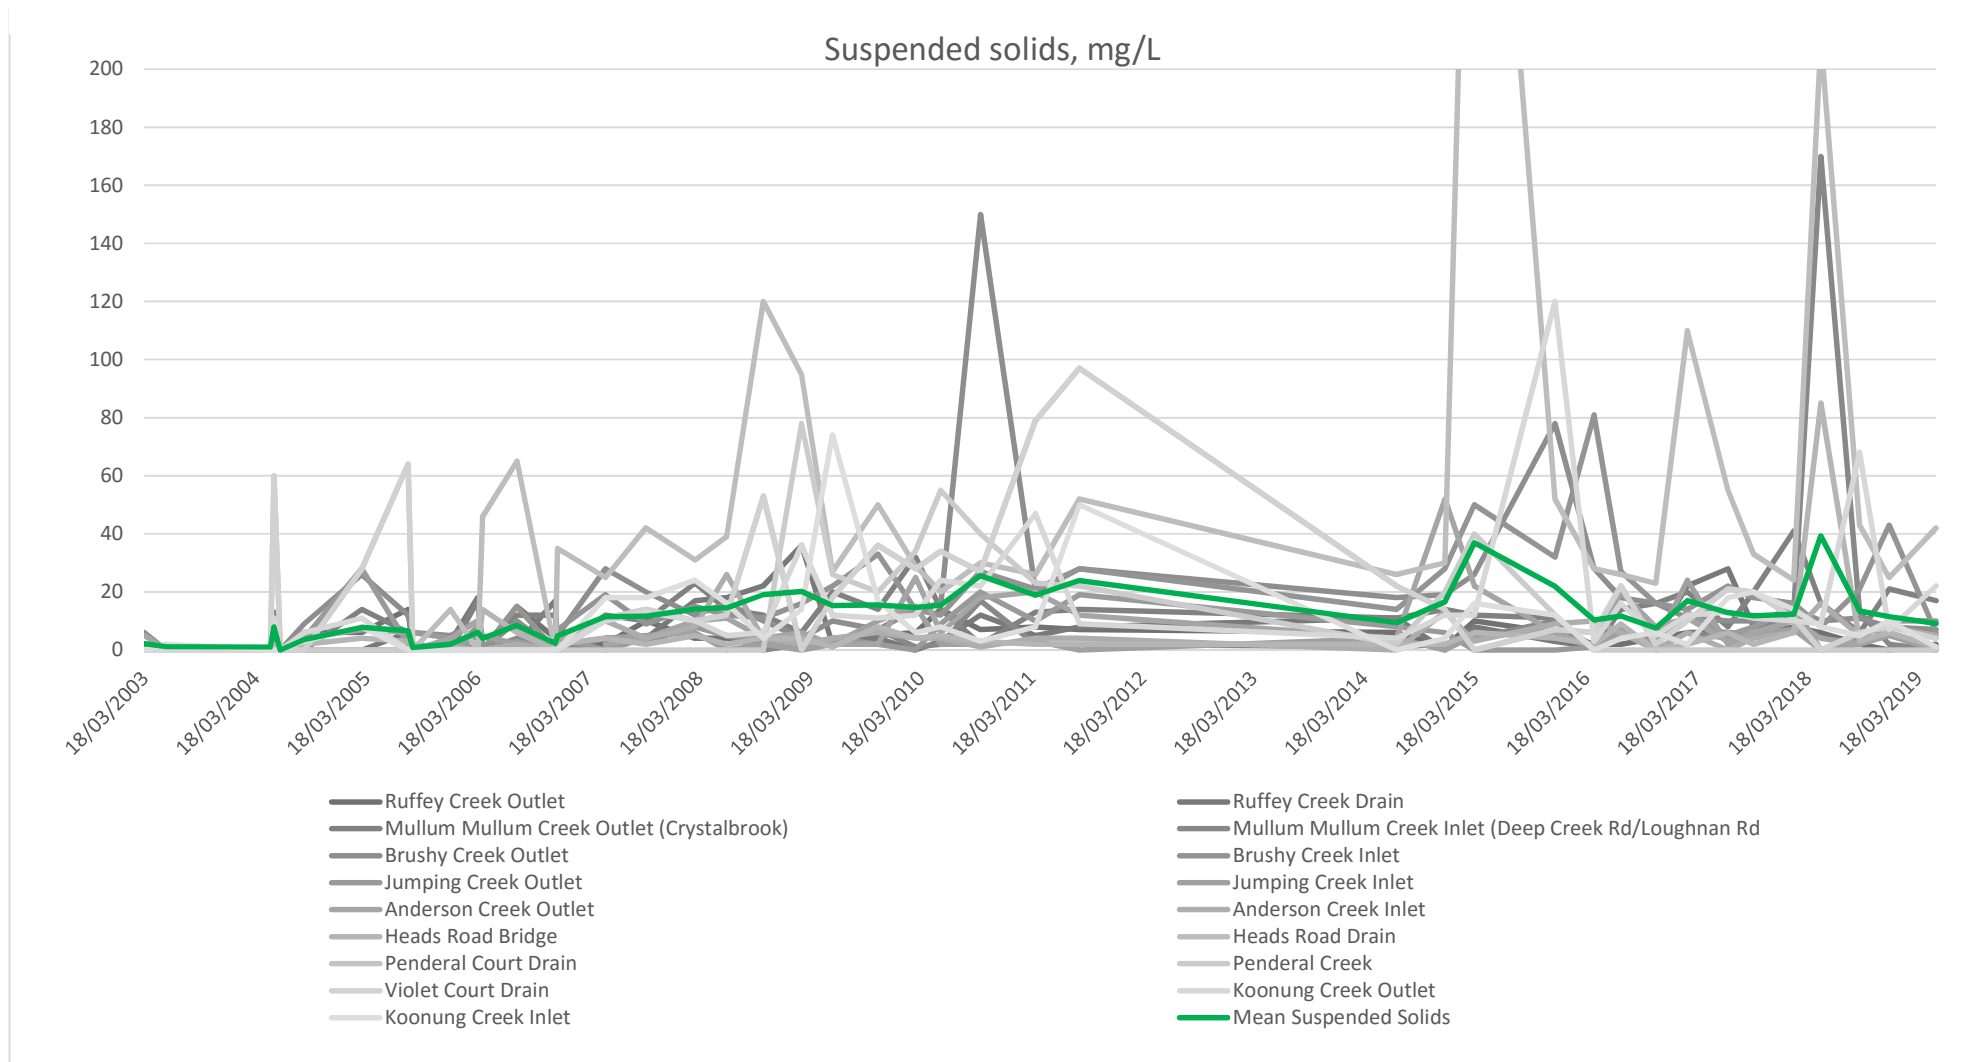
Figure 16: Suspended Solids by date and location
